QTR-2191-001

QUALIFICATION TEST REPORT FOR
450 GALLON CRASHWORTHY FUEL TANK
FOR
U.S. AIR FORCE H-53 HELICOPTER

QTR-2191

CRASH IMPACT TEST

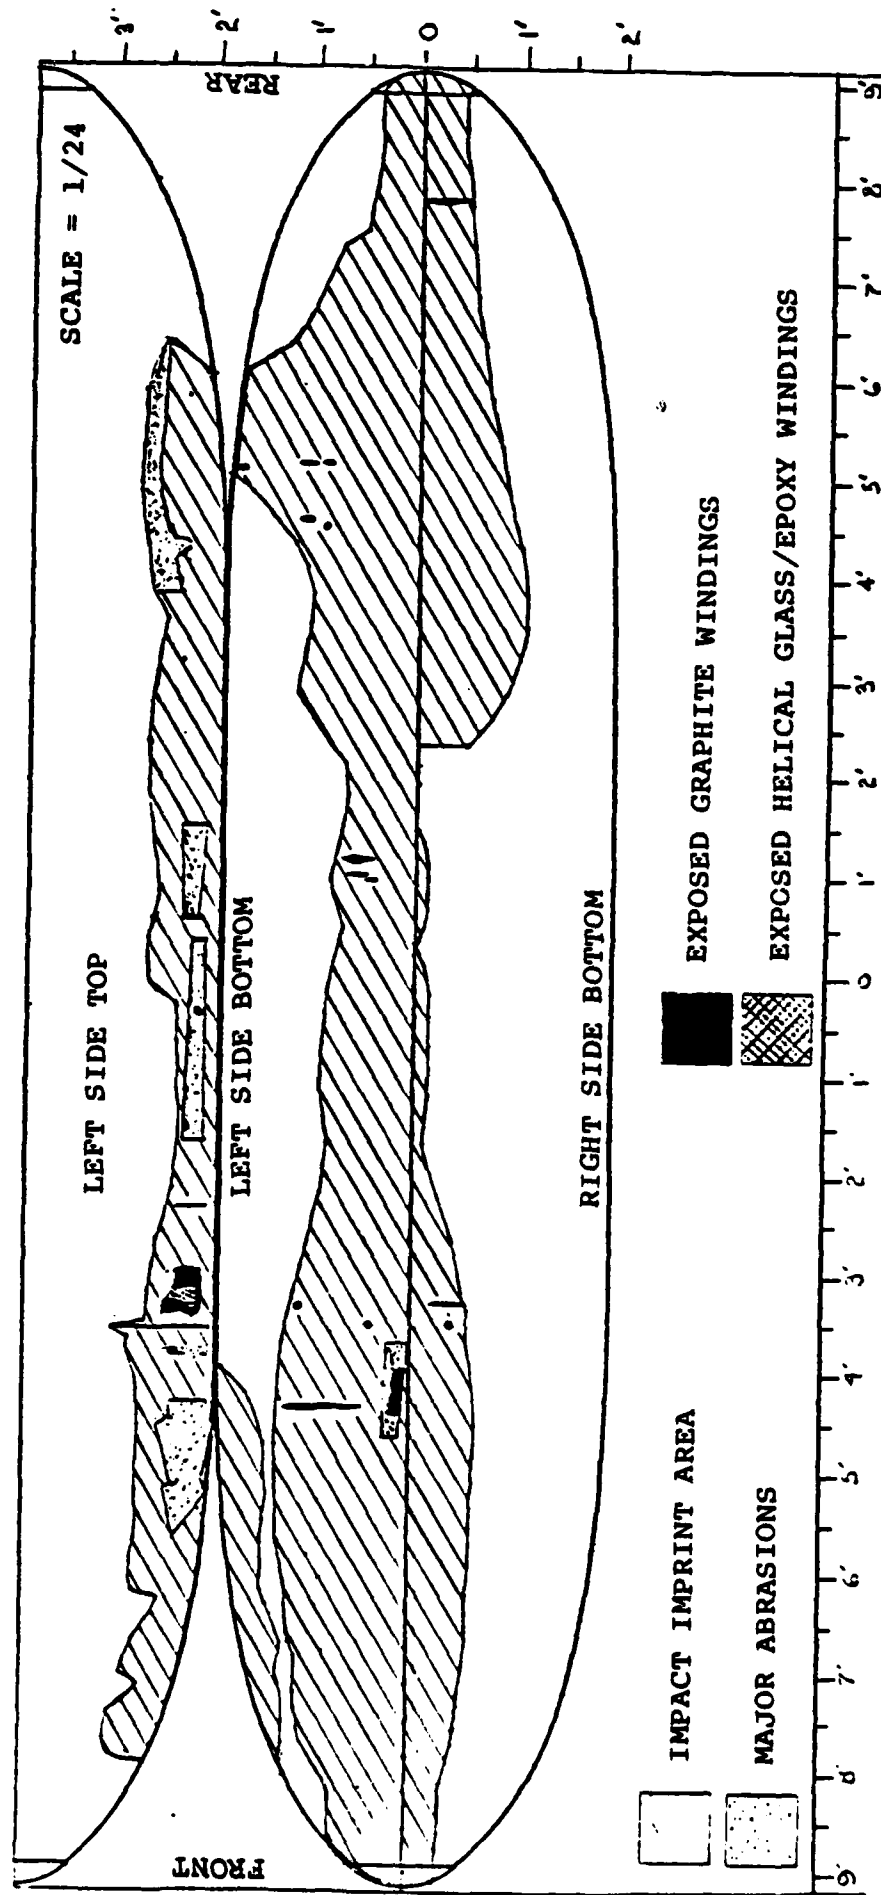
FIGURE 3-12. FUEL TANK SN0003 IMPACT IMPRINT SKETCH.

The impacted area of the tank includes both the bottom and left side of the tank. Majority of damage aside from ruptures and fractures consists of scuffing which exposed the yellow primer paint and circumferential windings. Near the drain plug and along the left side there are deeper scuffs exposing the graphite windings. On left side of tank, approximately even with the front of the pylon, there is a deep scuff down to helical glass/epoxy windings. Near the primary rupture there are several surface delaminations.

Figure 3-12 is a scaled sketch of the entire impact area.

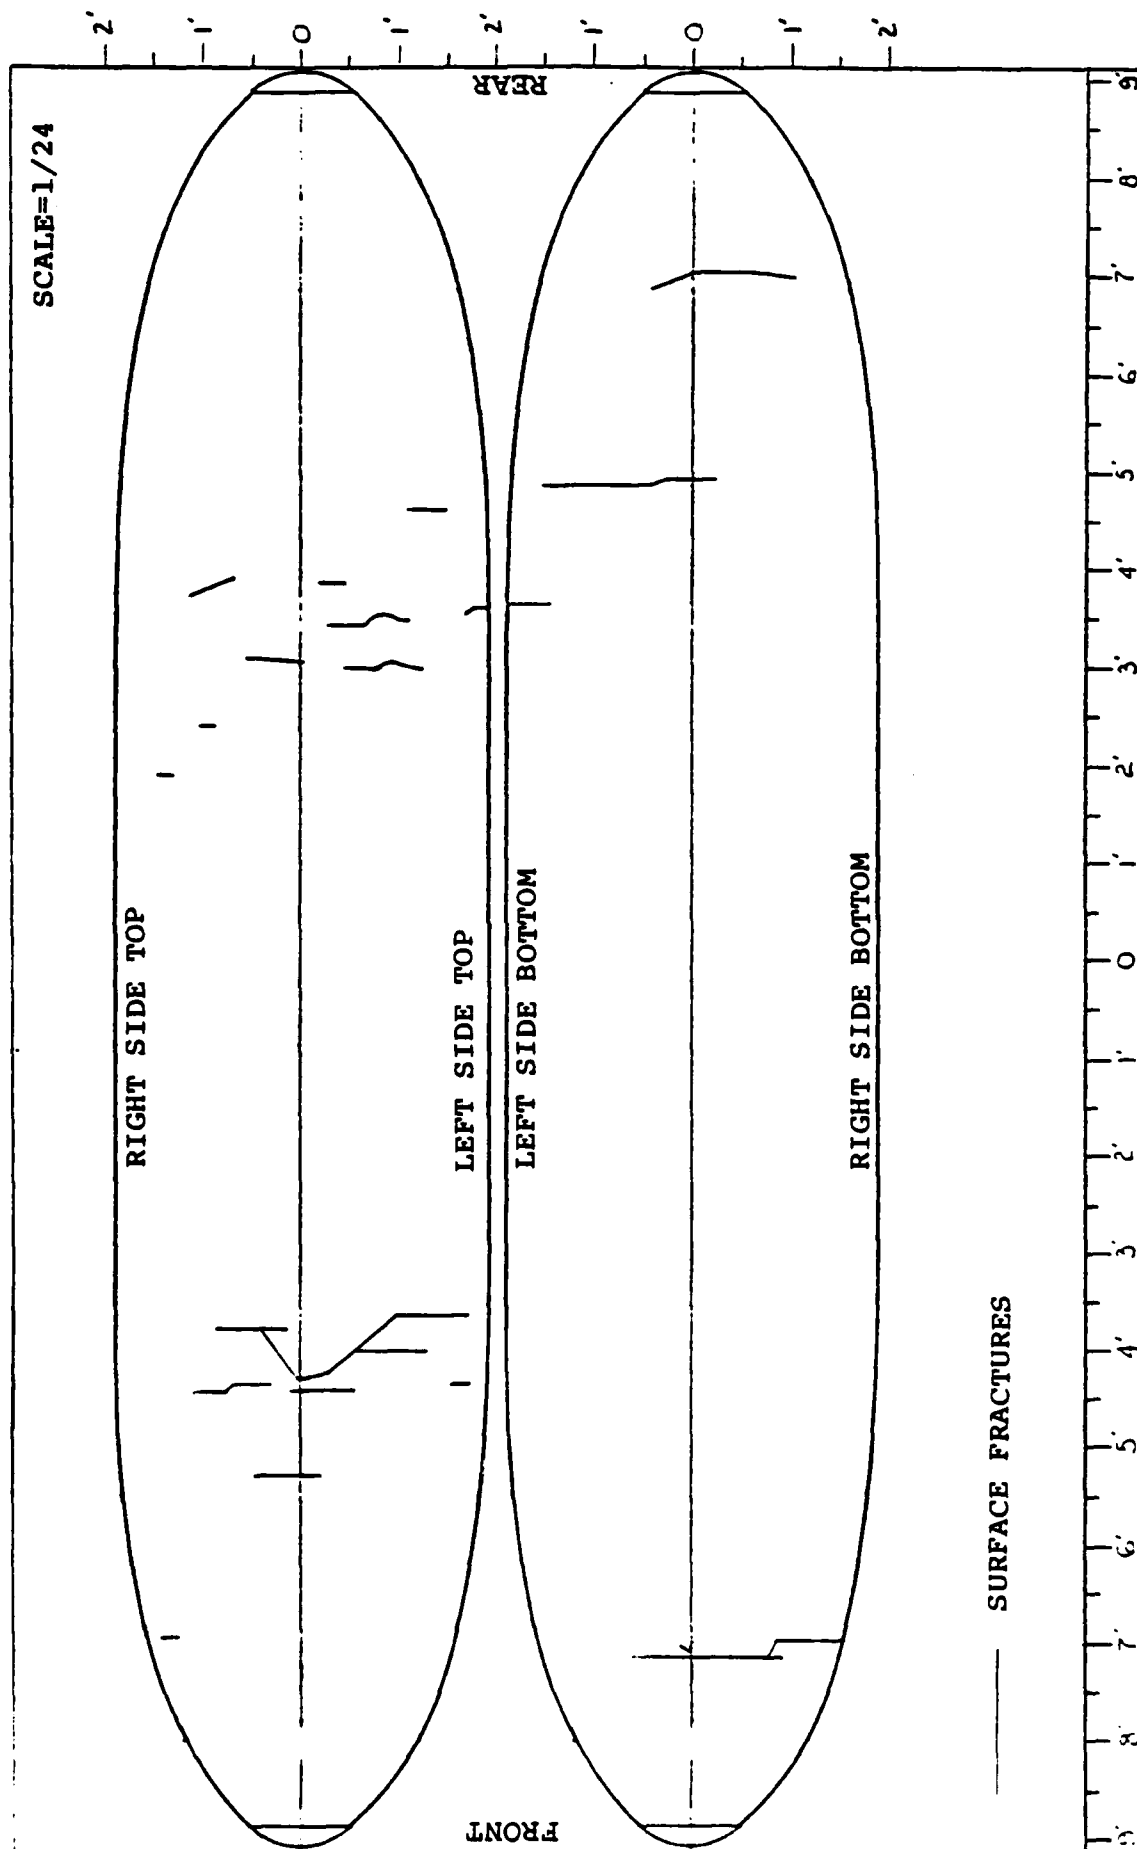
FIGURE 3-34. FUEL TANK SN0002 NON-RUPTURE SURFACE DAMAGE SKETCH.

General overall appearance is poor. There are two large ruptures, one fore and one aft. There are also three partial fractures on the bottom of the tank, one forward of the fore rupture, one just forward of the rear rupture, and one aft of the rear rupture near the tail. There are deep scuffs on the bottom and right side of the tank. Additionally, surface stress fractures are evident on the top and sides of the tank. Figure 3-34 is a sketch of non-rupture surface damage. Figure 3-35 shows a general view of damage to the bottom of the tank.

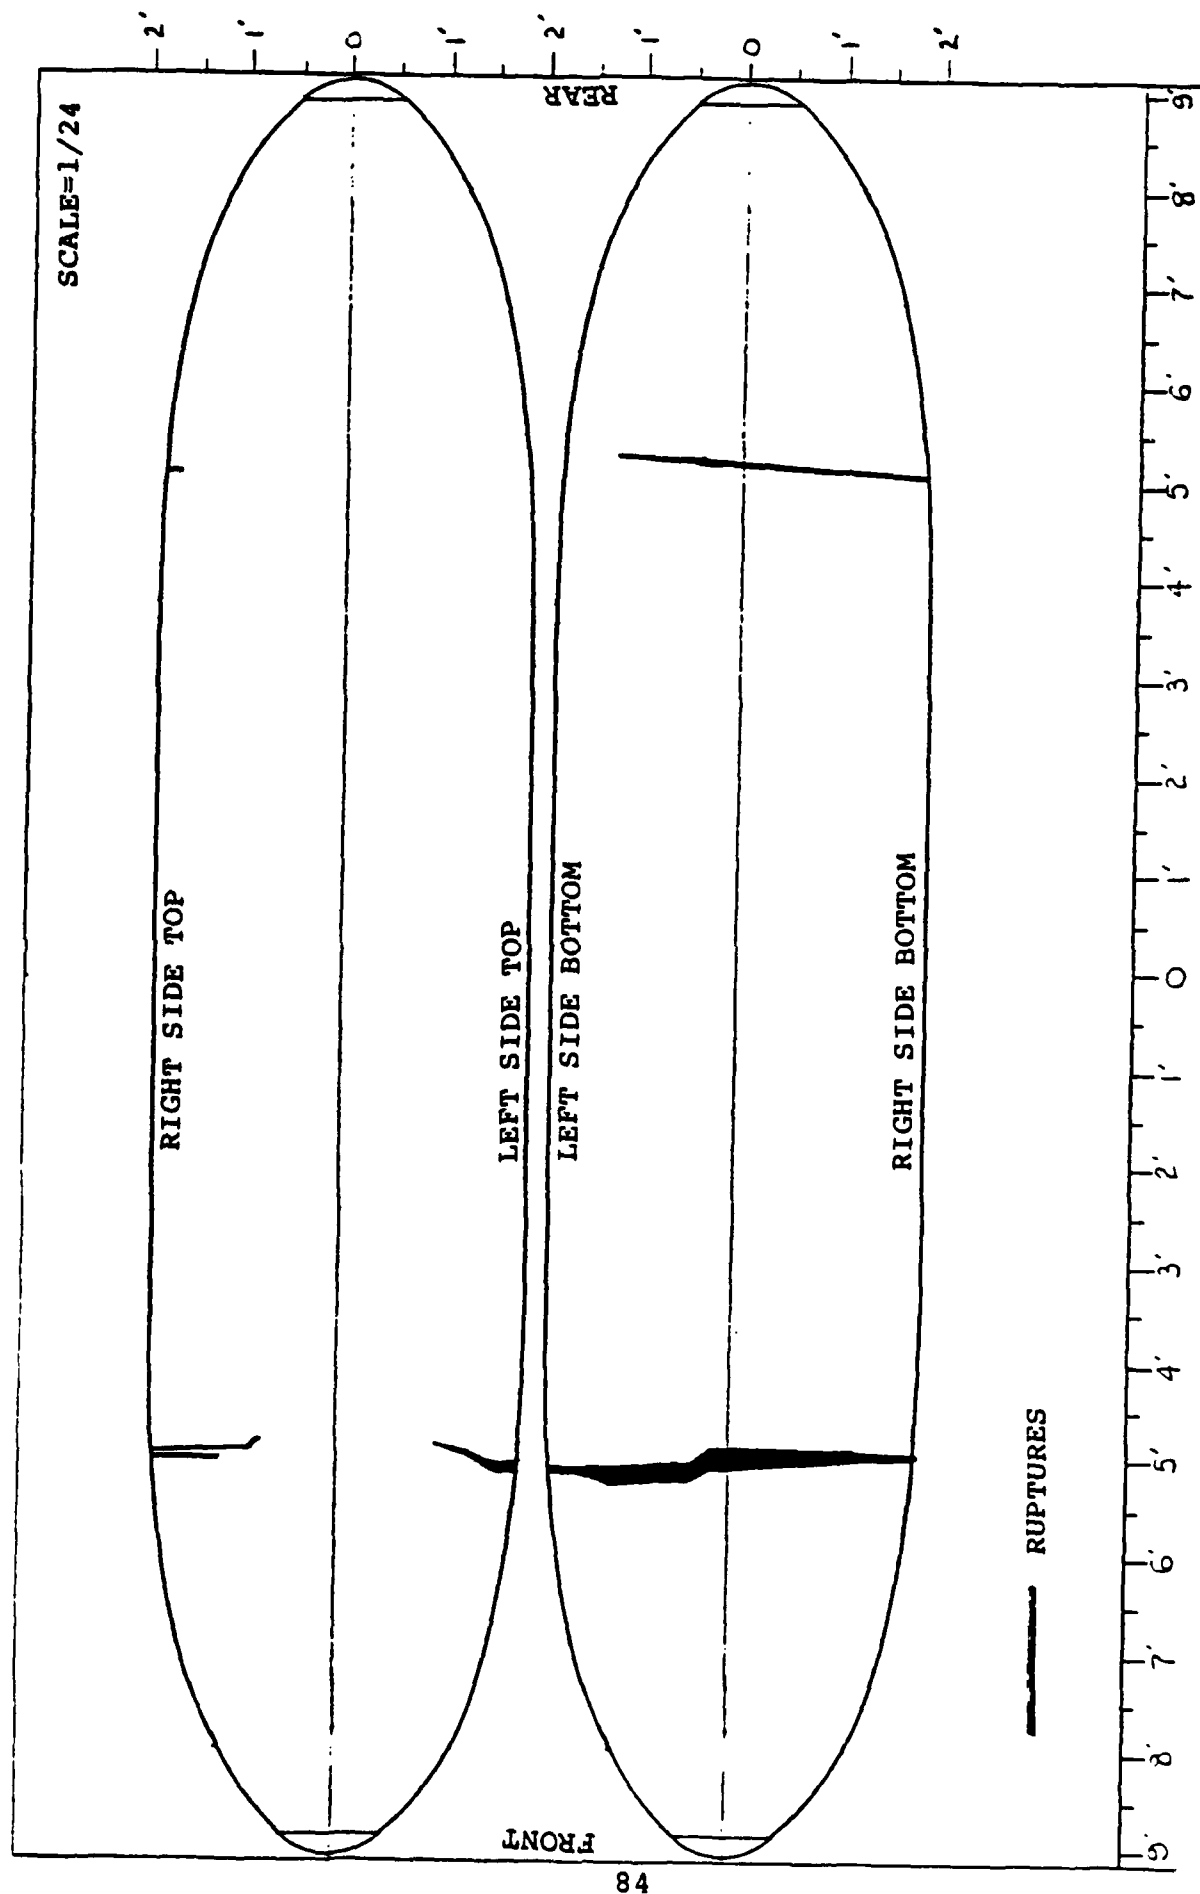
FIGURE 3-36. FUEL TANK SN0002 RUPTURE LOCATION SKETCH.

Two leakage locations were noted. Figure 3-36 is a scaled sketch of the rupture locations.

1. Jagged, tearing fissure extending about one-half circumference. Nearly all failure in helical windings, with some circumferential failure at bottom of tank. All layers down to thermoplastic liner exposed; more severe on tank left side. Pieces of honeycomb protruding through rupture. Figure 3-37 shows a close-up view of this rupture.
2. Very straight, narrow fissure extending approximately one-half circumference on bottom of tank. Nearly all failure in helical windings. All layers exposed down to thermoplastic liner. More of a clean splitting failure than the tearing of rupture 1. Figure 3-38 shows a close-up view of this rupture.

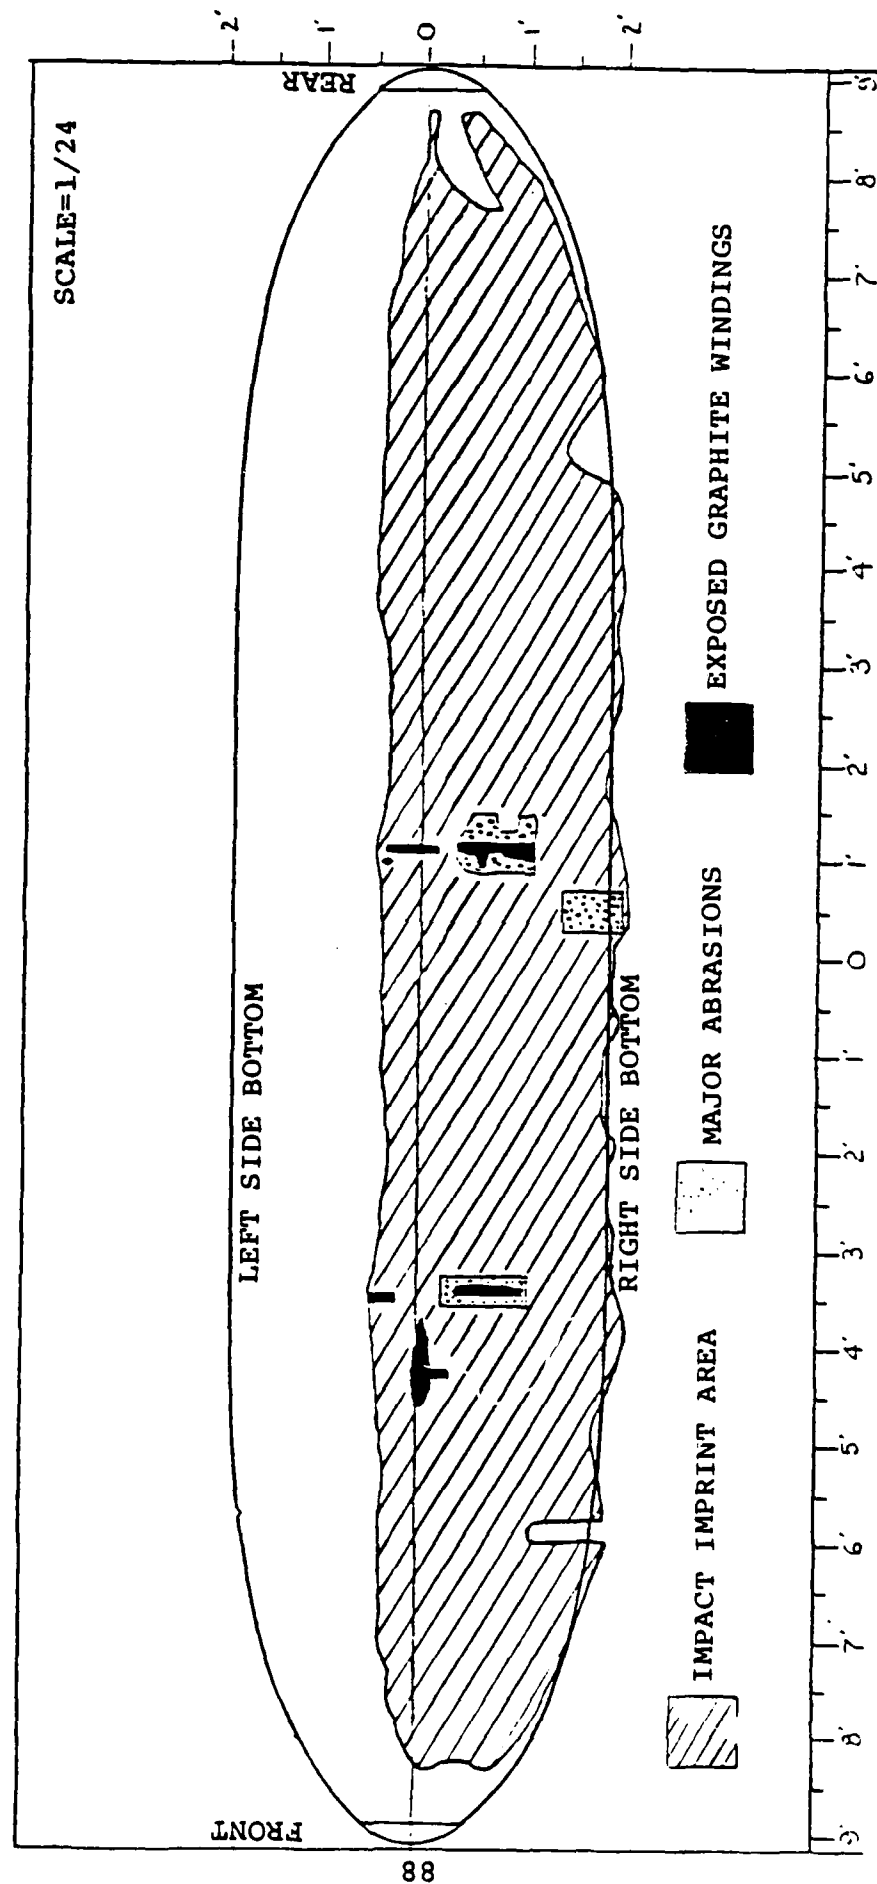
FIGURE 3-39. FUEL TANK SN0002 IMPACT IMPRINT SKETCH.

Aside from ruptures and fractures, most other damage consists of scuffing, exposing primarily yellow primer paint and outside layer of circumferential glass/epoxy windings. Graphite windings scuffed at front and rear. Graphite windings exposed on right side bottom aft of drain plug, also on right side bottom even with rear of pylon. Impact imprint consists of tank bottom and right side. Figure 3-39 is a scaled sketch of the impact imprint area. Figure 3-40 shows an overall view of the tank bottom impact area.

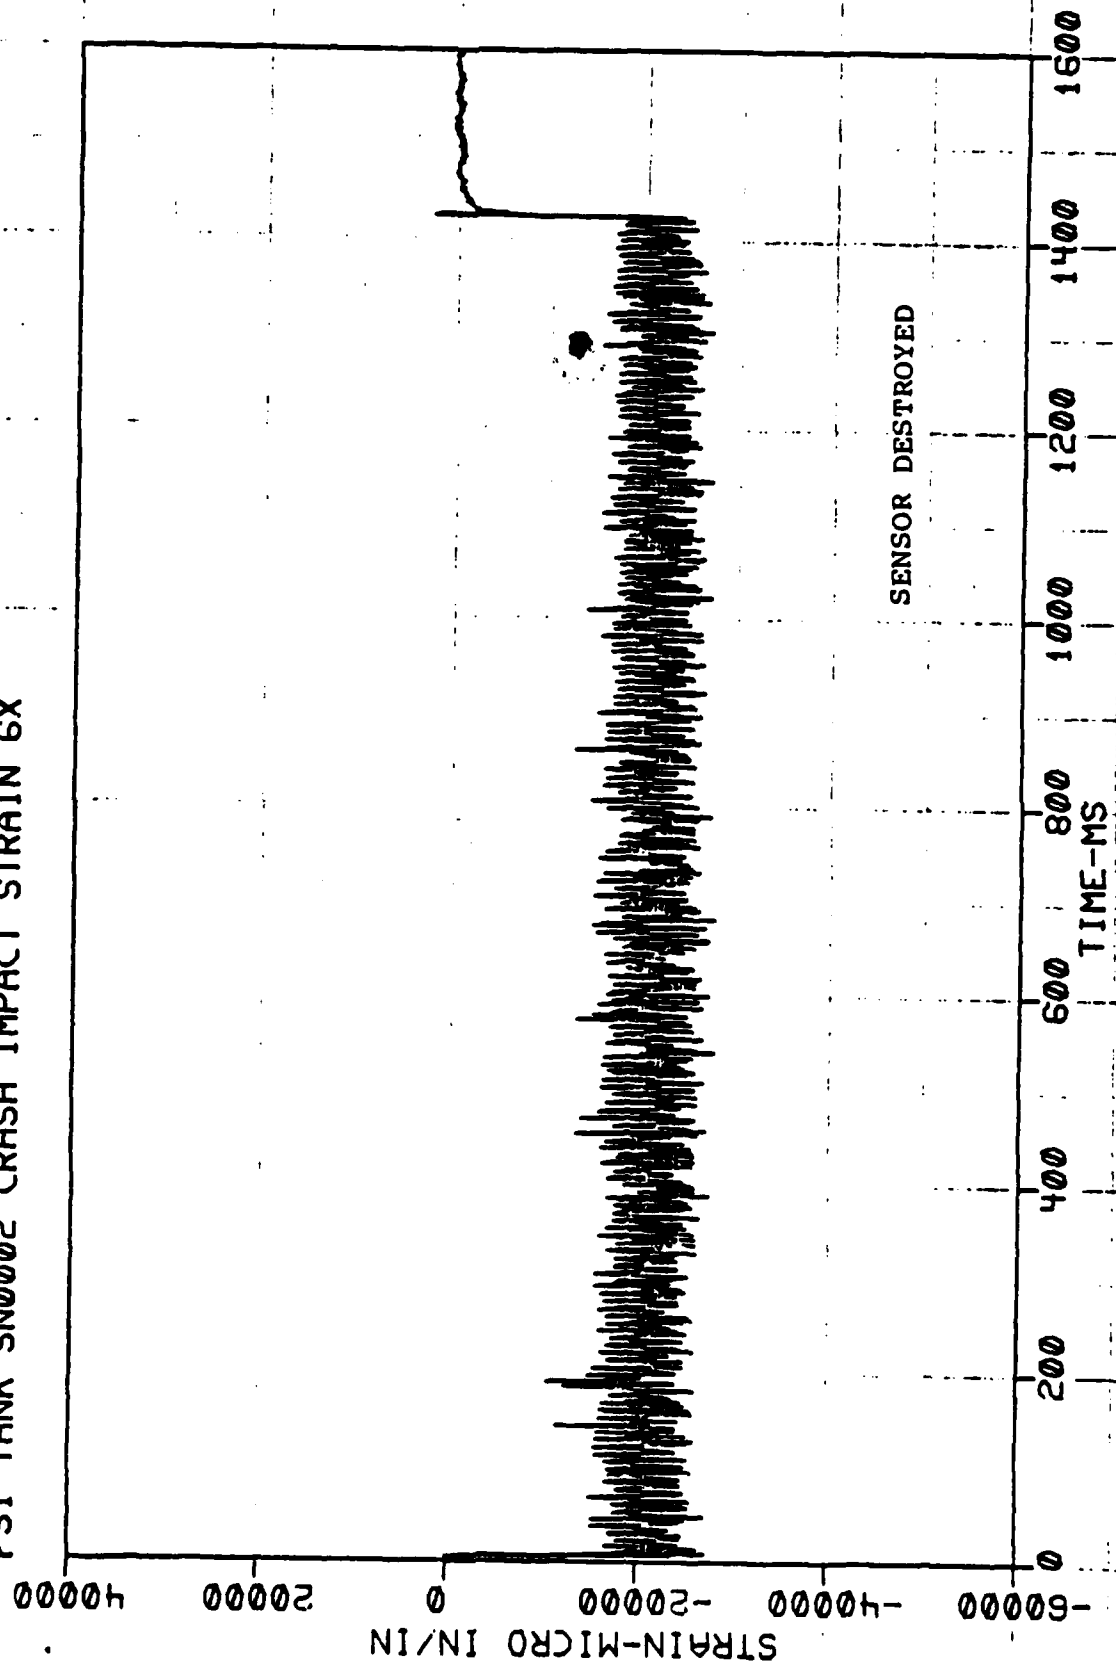
FSI TANK SN0002 CRASH IMPACT STRAIN 6X

SENSOR DESTROYED
